# Debris/Ice/TPS Assessment And Photographic Analysis For Shuttle Mission STS-40

July 1991

**Gregory N. Katnik**  
**NASA/Kennedy Space Center**

Shuttle Mission STS-40 was launched at 9:24 a.m. local 6/5/91

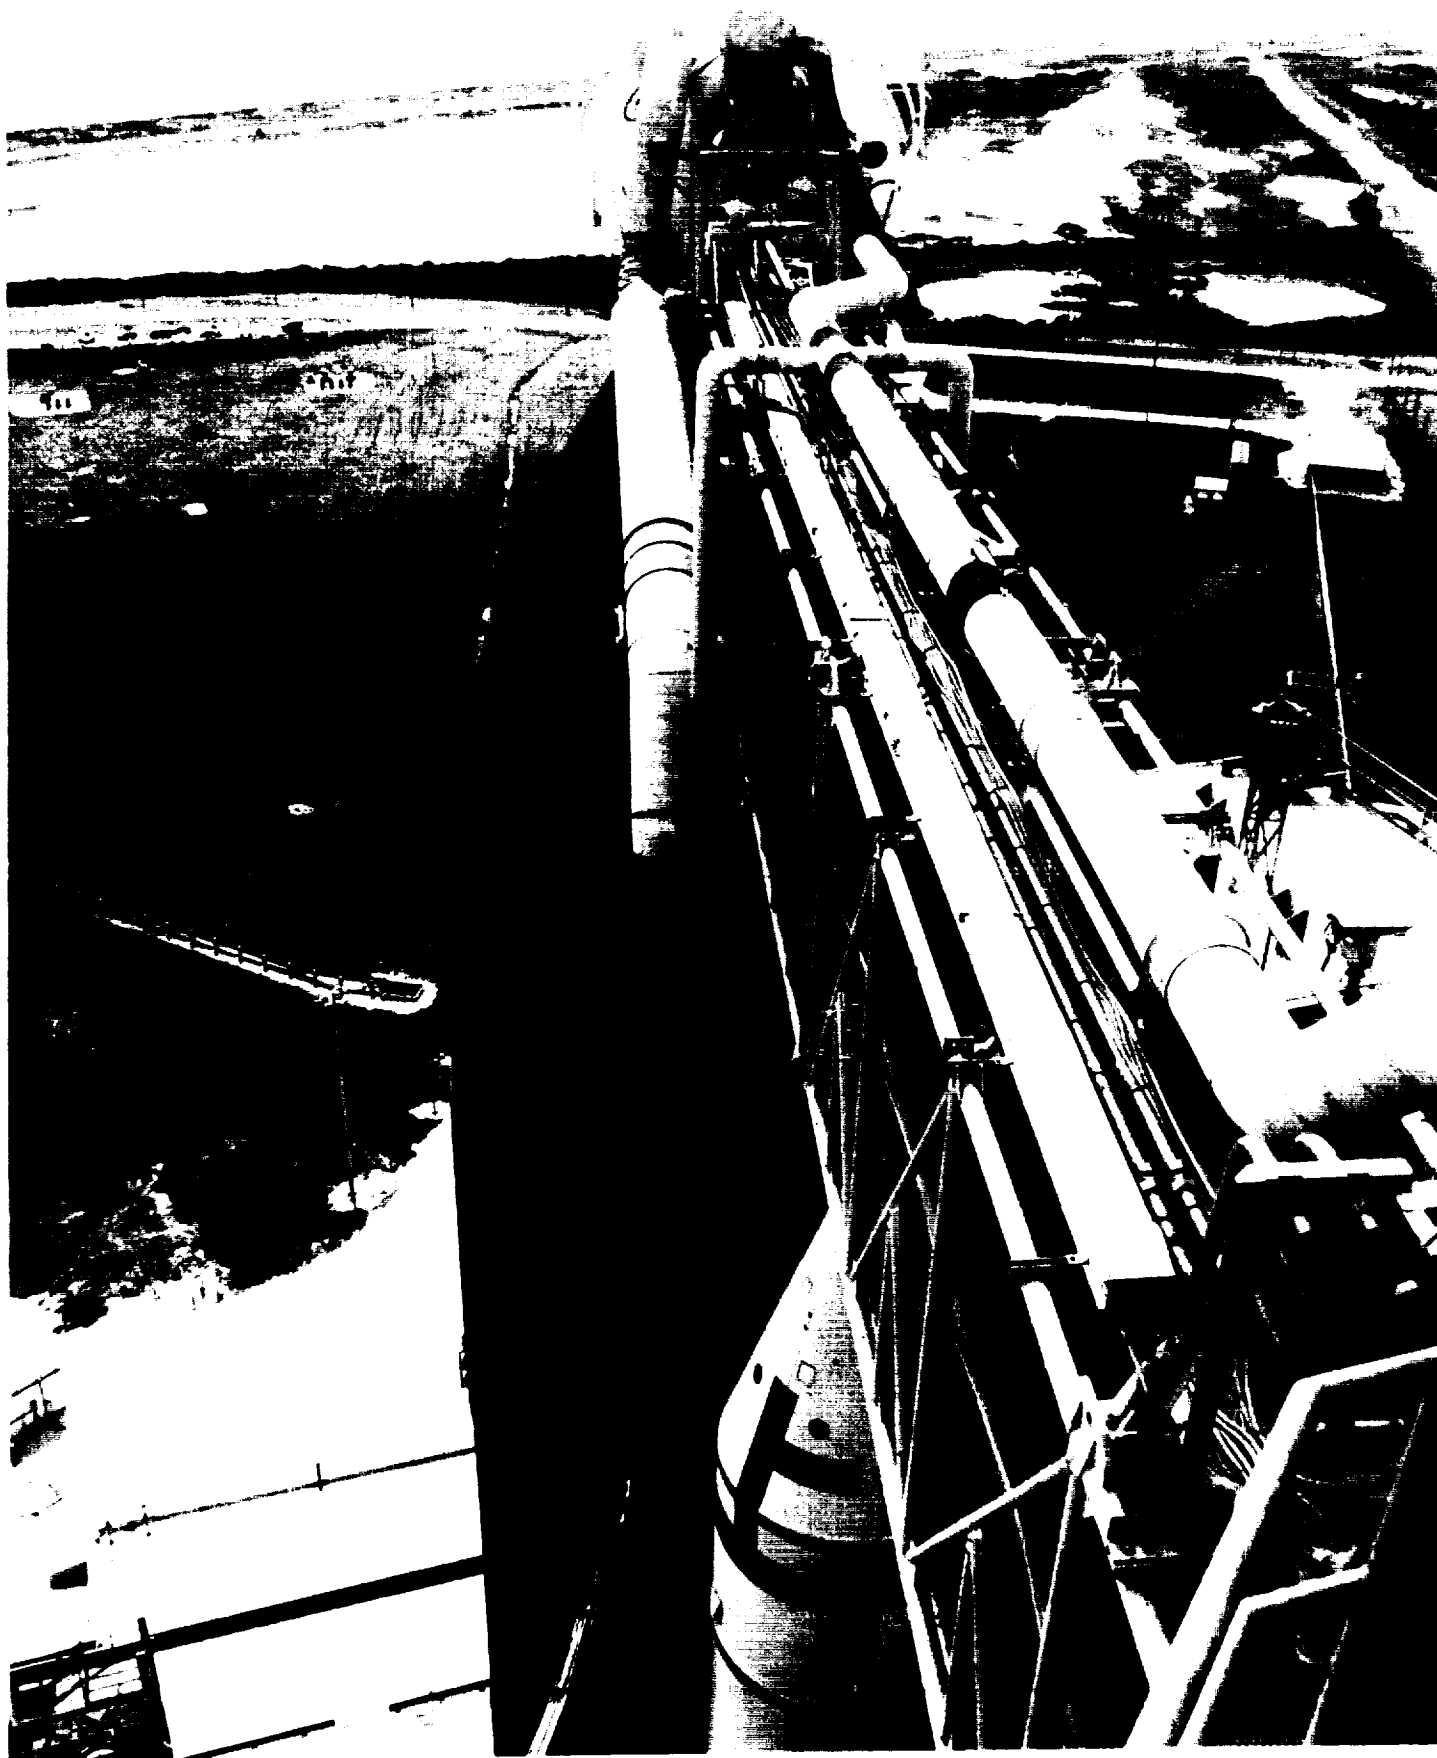
Hydraulic fluid leaked from the GOX vent arm hinge area and was blown toward the vehicle by prevailing winds. Hydraulic fluid drops were present on the -Y-Z quadrant of the External Tank and on the LH SRB. The Orbiter was sheltered by the RSS/OWP.

Although not readily apparent on the External Tank acreage TPS, the hydraulic fluid drops that fell from the GOX vent arm hinge area were more visible on the ET intertank access structure. Engineering evaluation determined the presence of the hydraulic fluid would not adversely affect the flight hardware TPS.

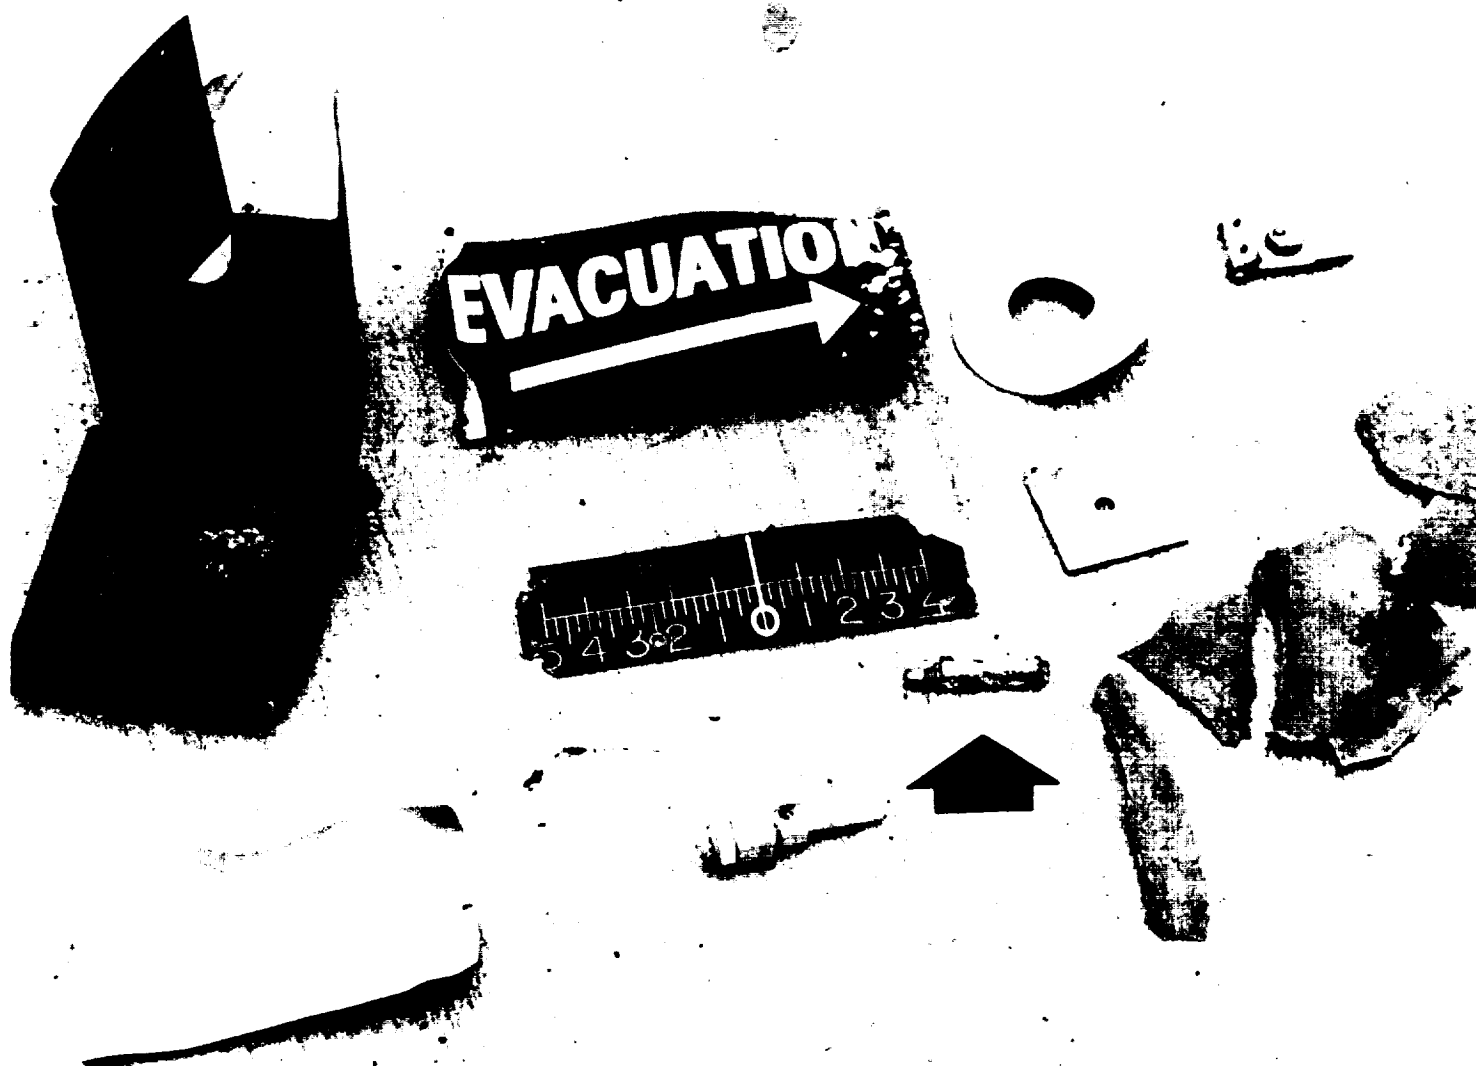
Typical facility debris was found on the pad after launch. A frangible nut fragment 3.25" x 1" x 0.5" from holddown post #5 (arrow) lay on the MLP deck under a sound suppression water pipe just east of the HDP #5 haunch. No flight hardware or TPS materials were found.

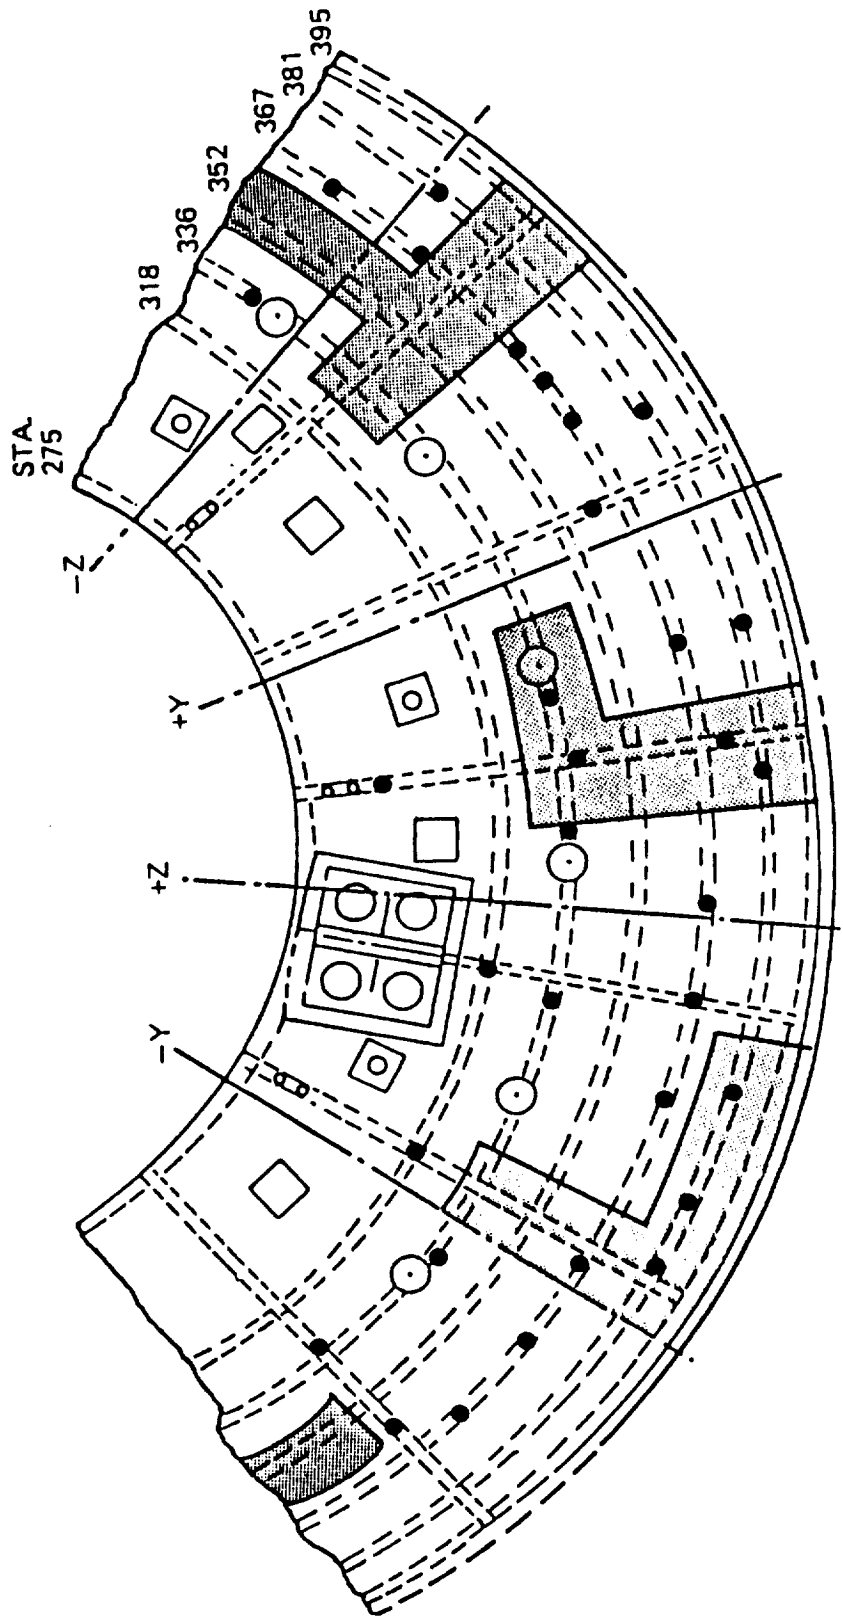
FIGURE 9. RIGHT SRB FRUSTUM

MISSING TPS  
NONE

DEBONDS  
32 MSA-2 DEBONDS  
OVER FASTENERS

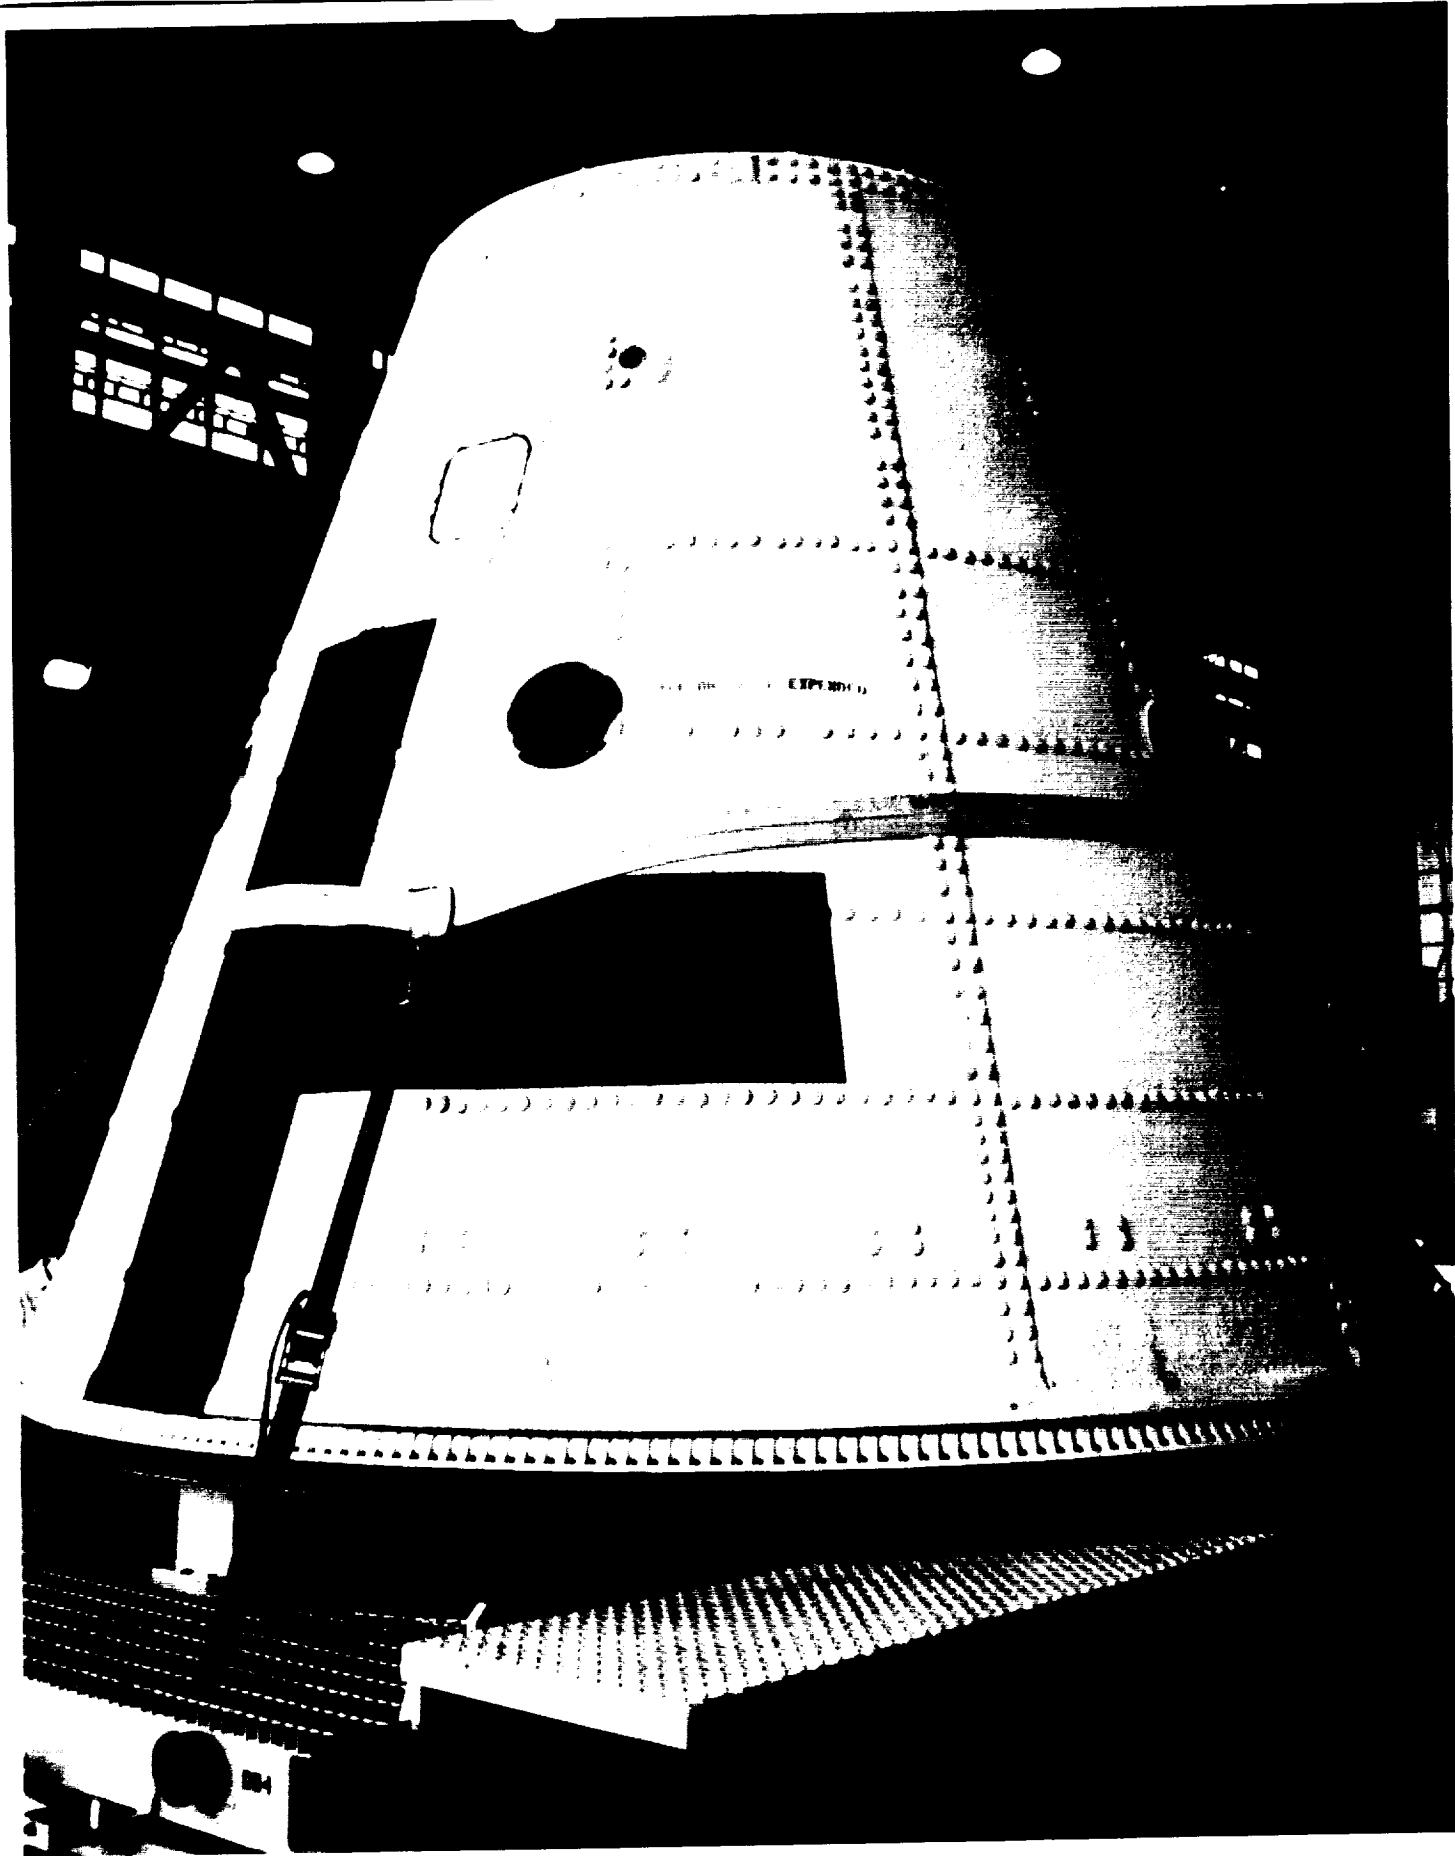
The RH frustum was not missing any TPS but had 32 MSA-2 debonds over fasteners.

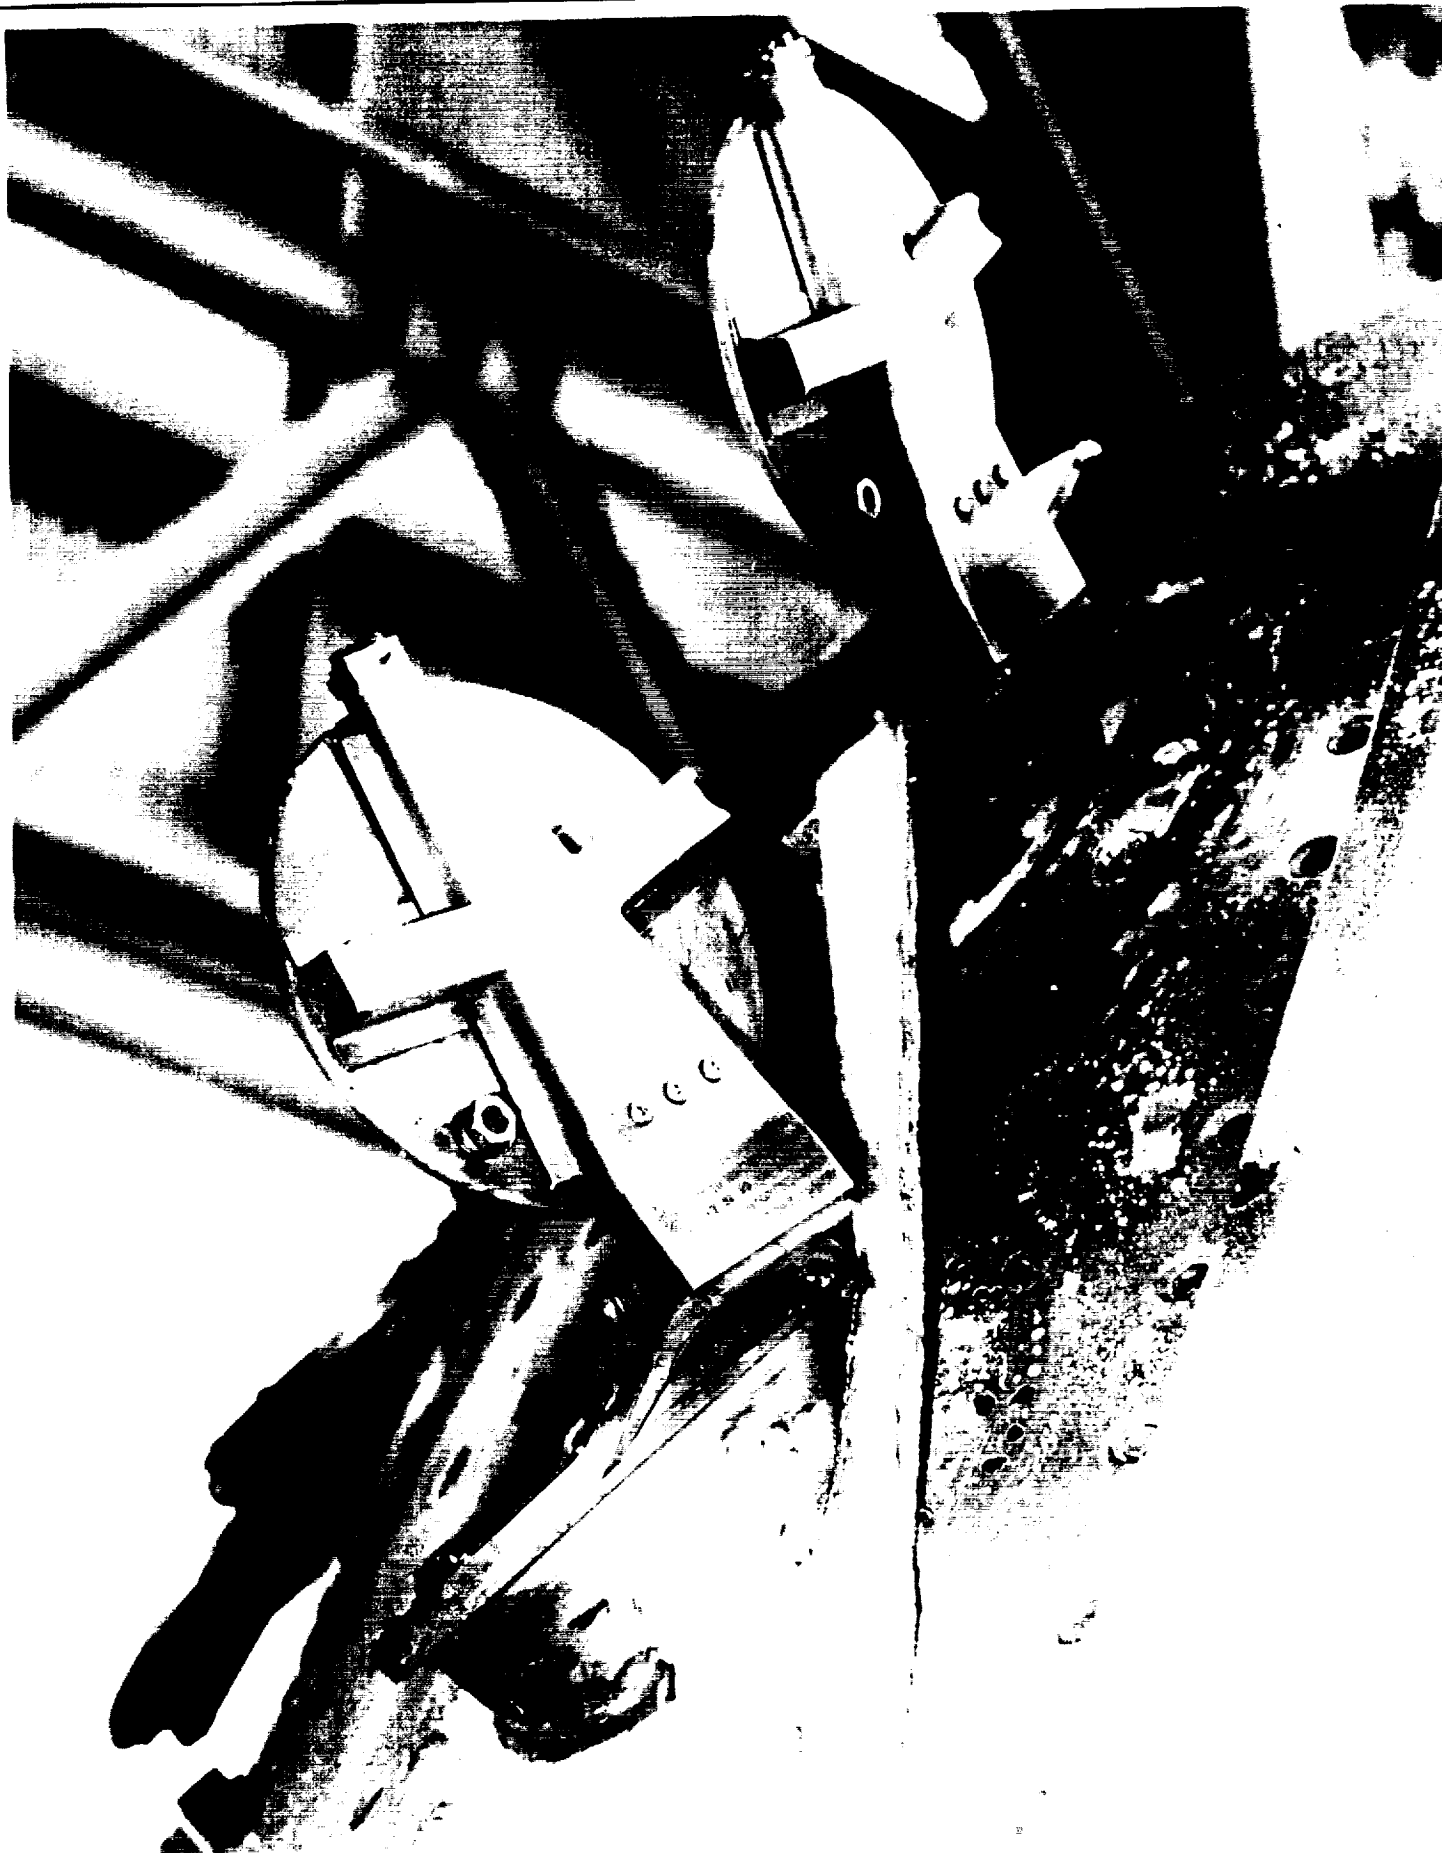
The BSM covers were locked in the open position, but two covers were bent upward by parachute riser entanglement.

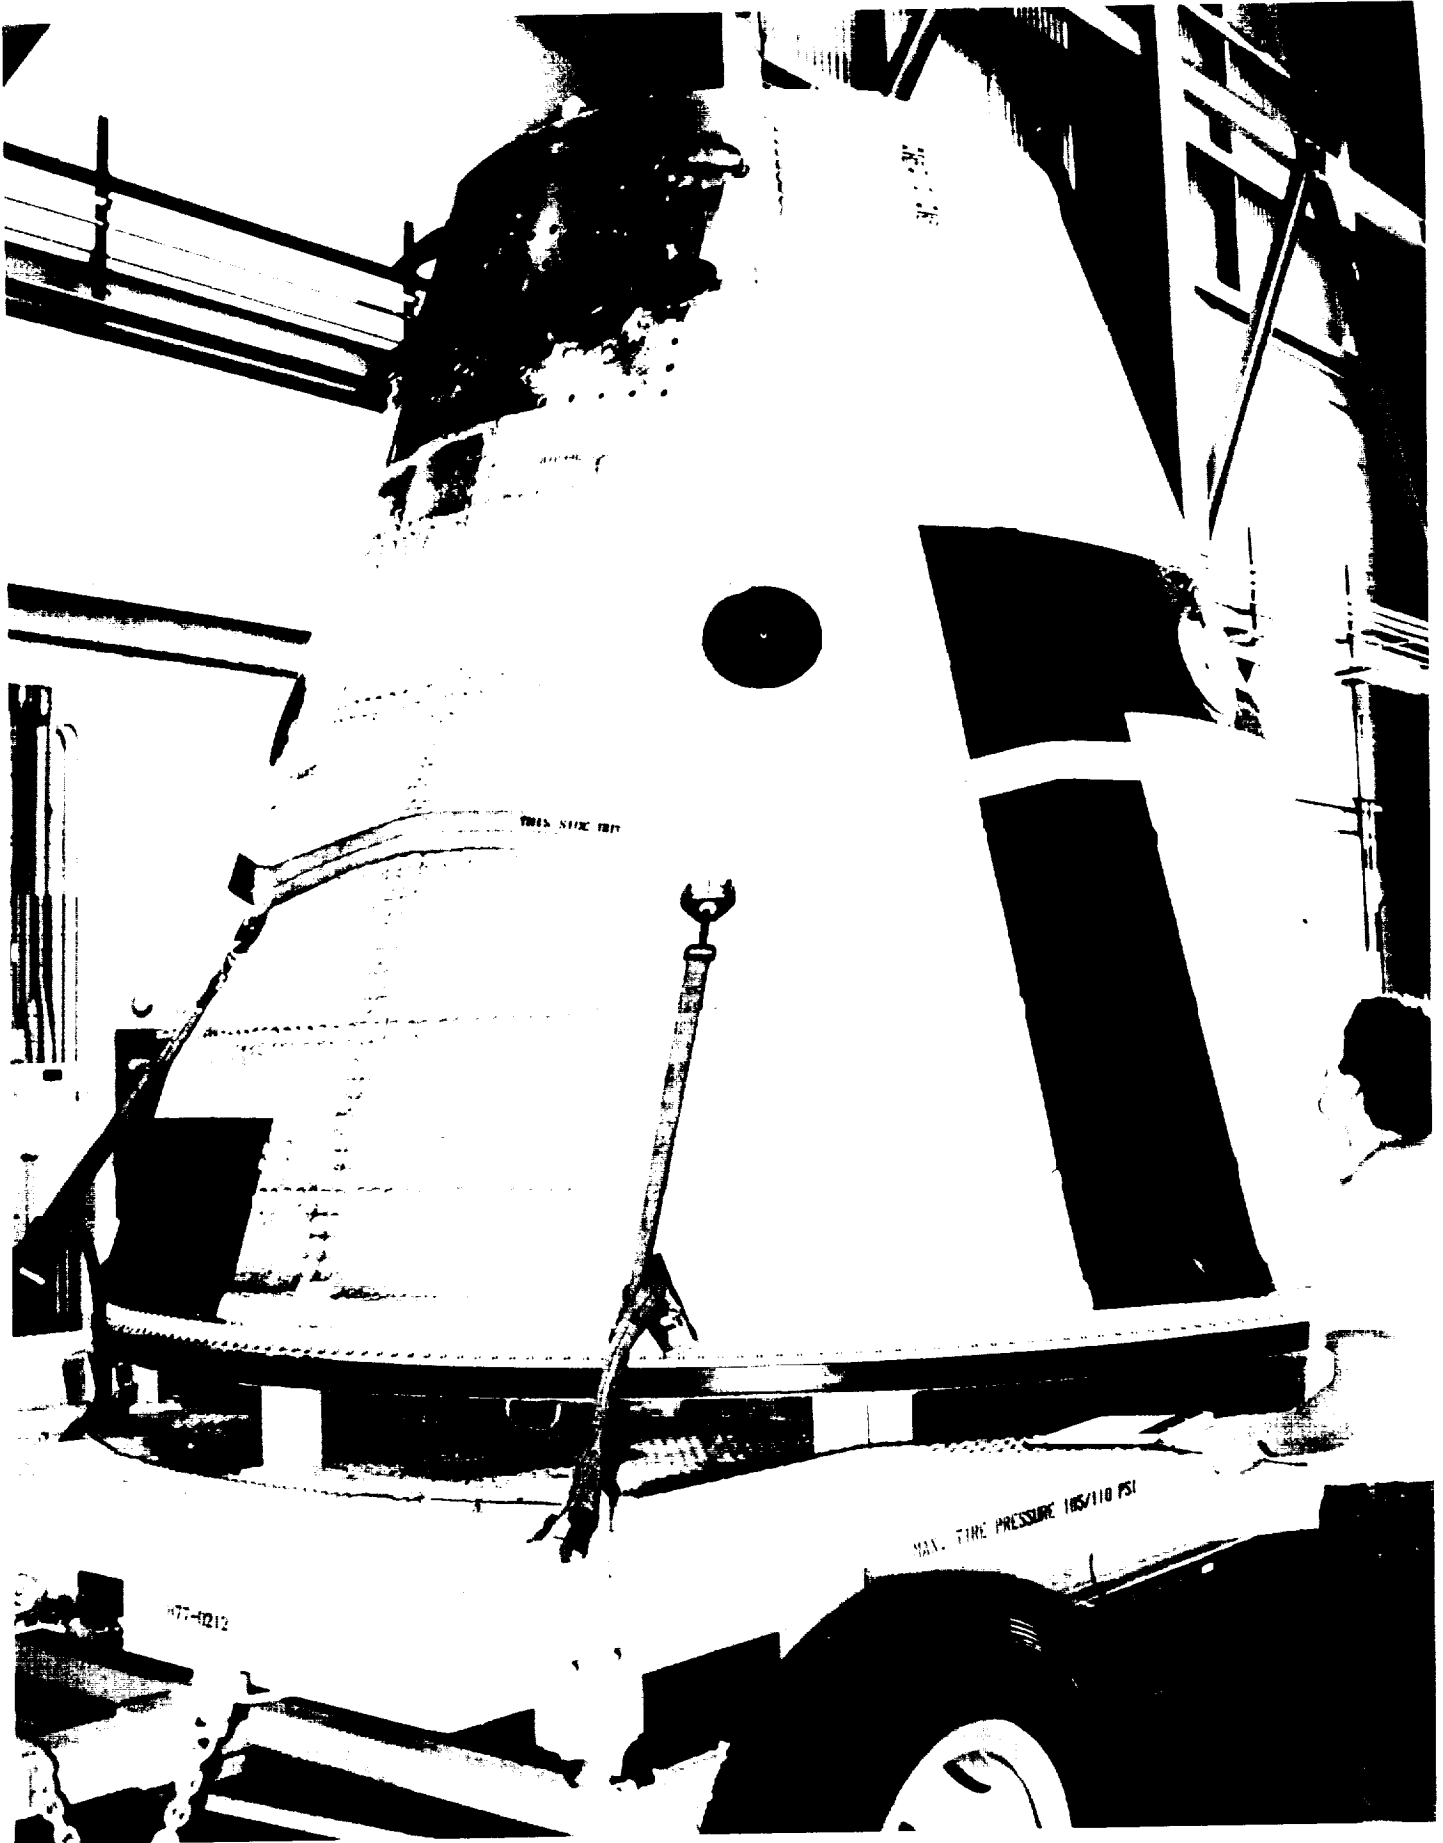
The LH frustum was not missing any TPS but had 30 MSA-2 debonds over fasteners
